Title Diagnostic / Troubleshooting Procedures For EGR System Components; Diagnostic Trouble Codes (DTC) P0401-00, P0402-00, P04DD-00, P1121-00, P1121-98 Or SPN 2659 FMI 16, SPN 2659 FMI 18, SPN 412 FMI 0, SPN 412 FMI 15 - **US10, US10+OBD13, US14+OBD\*, US17+OBD\* With A Variable Geometry Turbocharger (VGT)**

**Mack Model** LEU , LR , MRU - TerraPro , TE - TerraPro , AN - Anthem , CHU - Pinnacle, Axle back , CXU - Pinnacle, Axle front , GR - Granite , GU - Granite , PI - Pinnacle , TD - Titan

**Volvo Model** VNL , VNM , VNR , VNX , VAH , VHD , VT

Engine family 11L Engine , 13L Engine , MP7 , MP8

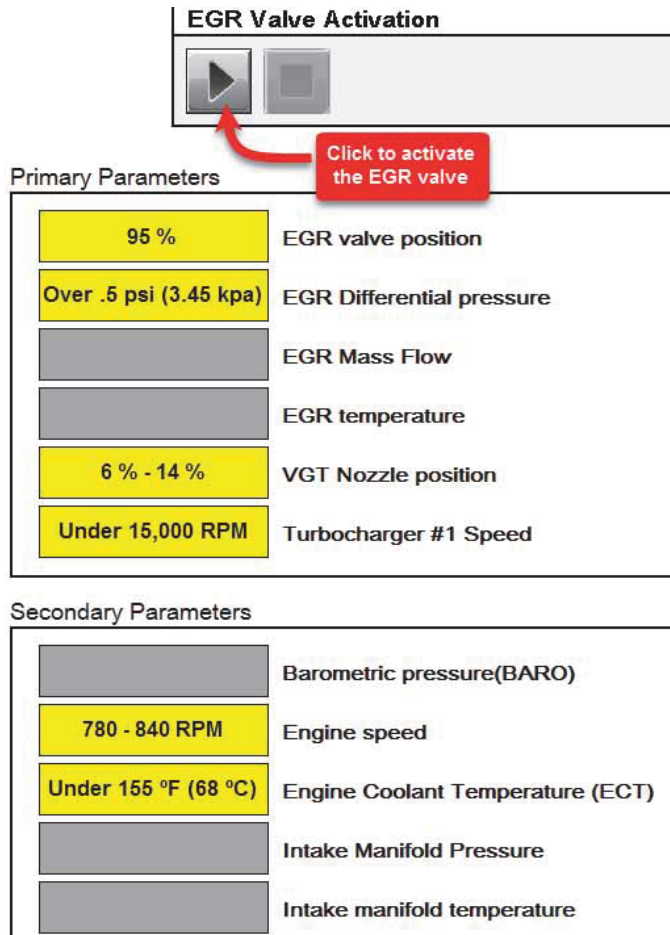
**Screenshot** : Should be taken with Conditions (in **YELLOW**) achieved and showing EGR valve at 95% just before the valve closes again OR the engine dies.

- **Turbocharger speed should drop below 15,000 RPM within 10 seconds of valve activation.**
- **If turbo speed does not change**, the EGR valve should be checked to confirm it is not stuck closed.

- **If turbo speed drops but remains above 20,000 RPM**, the EGR cooler is likely plugged.
  - A turbo speed reaction to EGR valve activation is a normal indicator of an operational EGR valve.

- The Venturi tube should also be checked to ensure it is free of blockage (Much less likely).
- **If turbo speed reacts as expected**, the EGR differential pressure sensor or EGR Temperature Sensor are the likely issue for High or Low Flow codes.
