Bendix™ VORAD® VS-400 Radar System

Troubleshooting Guide

Bendix™ VORAD® Collision Warning System
Bendix™ SmartCruise® Adaptive Cruise Control
Bendix™ BlindSpotter® Side Object Detection
BW2771 (Formerly VOTS0100)

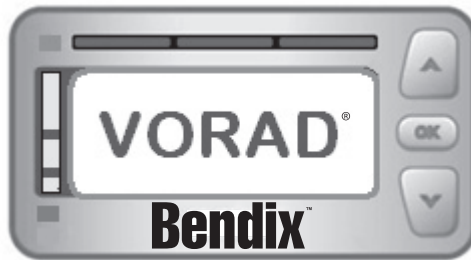
With the vehicle's ignition turned to the ON position (Engine OFF), observe the power-up sequence of the VS-400 Driver Interface Unit (DIU).

VS-400 DIU Lamp Test at initial power-up

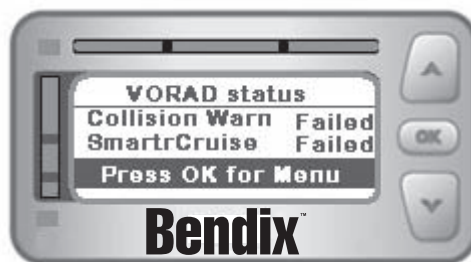
After about 30 seconds from when the ignition was powered on, the DIU should display the VORAD status screen. This screen will display which functions are enabled and if that function's operation is OK or Failed.

If a function has failed, the orange Diagnostic Trouble Code (DTC) lamp will be illuminated, indicating an Active code has been set. Proceed to the Retrieving Diagnostic Trouble Codes (DTCs) section.

VORAD status screen showing both Collision Warning System and Bendix SmartCruise® enabled but failed

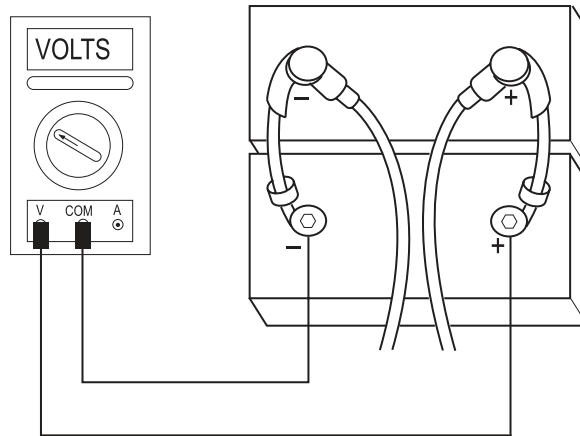
Step	Procedure
A	<ol style="list-style-type: none">1. Vehicle Ignition: Key-ON, Engine-OFF.2. Measure and record the vehicle battery voltage at the battery terminals.<ol style="list-style-type: none">a. If the battery voltage measures within 2 volts of the battery-rated voltage. (10-12 volts for a 12-volt battery)<ol style="list-style-type: none">i. Proceed to Step Bb. If the battery voltage measures less than 2 volts of the battery-rated voltage. (less than 10 volts for a 12-volt battery)<ol style="list-style-type: none">i. Test Failed. Check batteries and charging system for proper operation, repair as required. Repeat Step.

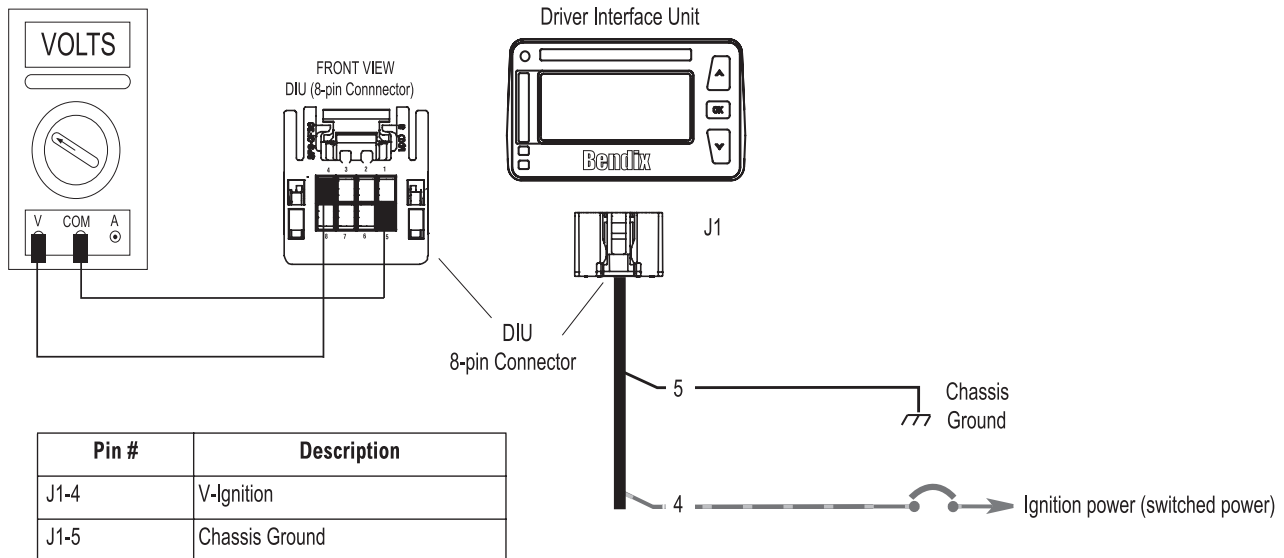
Step	Procedure
B	<ol style="list-style-type: none"> 1. Vehicle Ignition: Key-OFF, Engine-OFF. 2. Disconnect the 8-way connector from the back of the VS-400 Driver Interface Unit (DIU). 3. Measure for zero voltage on pins 4 and 5 on the harness connector. <ol style="list-style-type: none"> a. If the voltage is 0.5 volts or less. <ol style="list-style-type: none"> i. Proceed to Step C. b. If the voltage is greater than 0.5 volts, but less than battery voltage. <ol style="list-style-type: none"> i. Test Failed. Check DIU power supply wiring for sources of stray voltage or shorts to voltage. c. If the voltage is within 0.6 volts of the battery voltage measured in Step A. <ol style="list-style-type: none"> i. Test Failed. The DIU is improperly wired to battery power. Correct the wiring by connecting the FLR to ignition power and repeat Step.

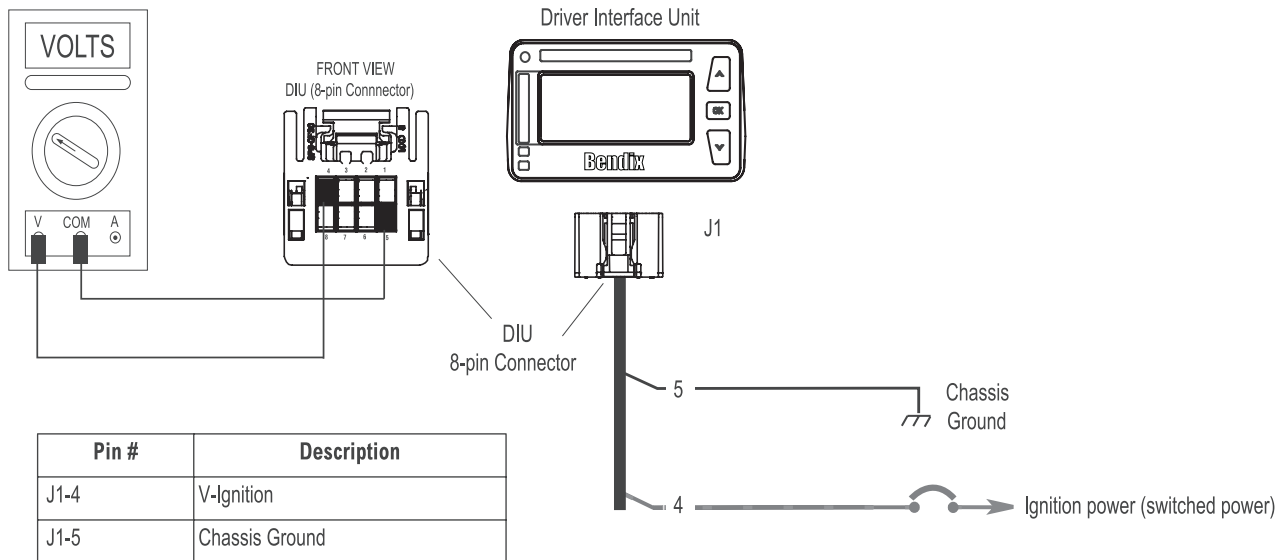
Step	Procedure
C	<ol style="list-style-type: none"> 1. Vehicle Ignition: Key-ON, Engine-OFF. 2. Measure for ignition voltage on pins 4 and 5 on the harness connector. <ol style="list-style-type: none"> a. If the voltage is within 0.6 volts of the battery voltage measured in Step A. <ol style="list-style-type: none"> i. Proceed to Step D. b. If the voltage is less than 0.6 volts of the battery voltage measured in Step A or open. <ol style="list-style-type: none"> i. Test Failed. Check component fuse. Troubleshoot power supply to the DIU for open/corroded connections or shorts to ground and repeat Step.

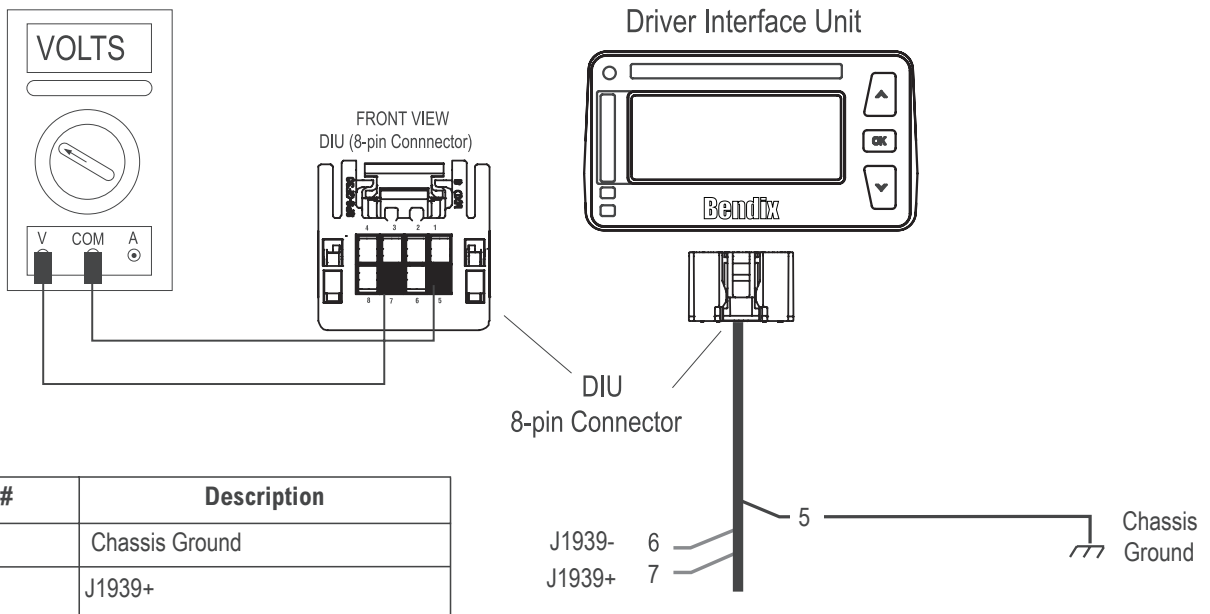
Step	Procedure
D	<ol style="list-style-type: none"> 1. Vehicle Ignition: Key-ON, Engine-OFF. 2. Measure for J1939 data voltage on pins 7 and 5 of the DIU harness connector. (J1939 High to Ground) <ol style="list-style-type: none"> a. If the voltage is fluctuating between 2 to 5 volts. <ol style="list-style-type: none"> i. Proceed to Step E. b. If the voltage is a constant at 0 volts. <ol style="list-style-type: none"> i. Test Failed. Check for open/loose connections in the vehicle's J1939 data link harness. (See Note) <p>Note: Refer to vehicle OEM repair manual or contact the OEM for more information on the J1939 data link harness.</p>

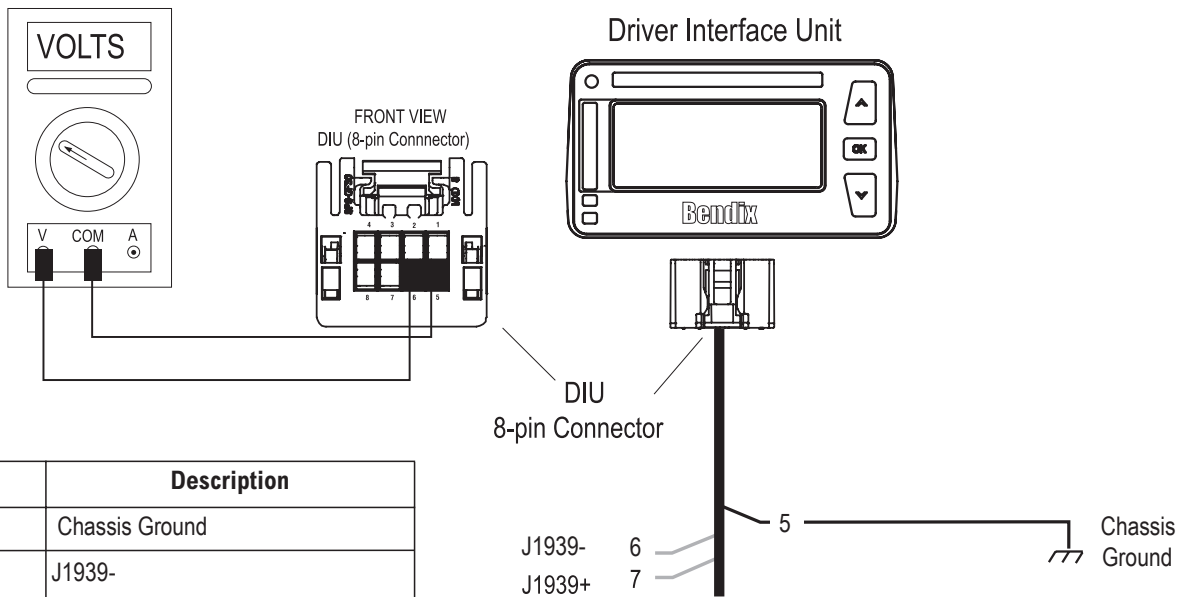
Step	Procedure
E	<ol style="list-style-type: none"> 1. Vehicle Ignition: Key-ON, Engine-OFF. 2. Measure for J1939 data voltage on pins 6 and 5 of the DIU harness connector. (J1939 Low to Ground) <ol style="list-style-type: none"> a. If the voltage is fluctuating between 0 to 3 volts. <ol style="list-style-type: none"> i. Proceed to Step F. b. If the voltage is a constant at 0 volts. <ol style="list-style-type: none"> i. Test Failed. Check for open/loose connections in the vehicle's J1939 data link harness. (See Note) <p>Note: Refer to vehicle OEM repair manual or contact the OEM for more information on the J1939 data link harness.</p>

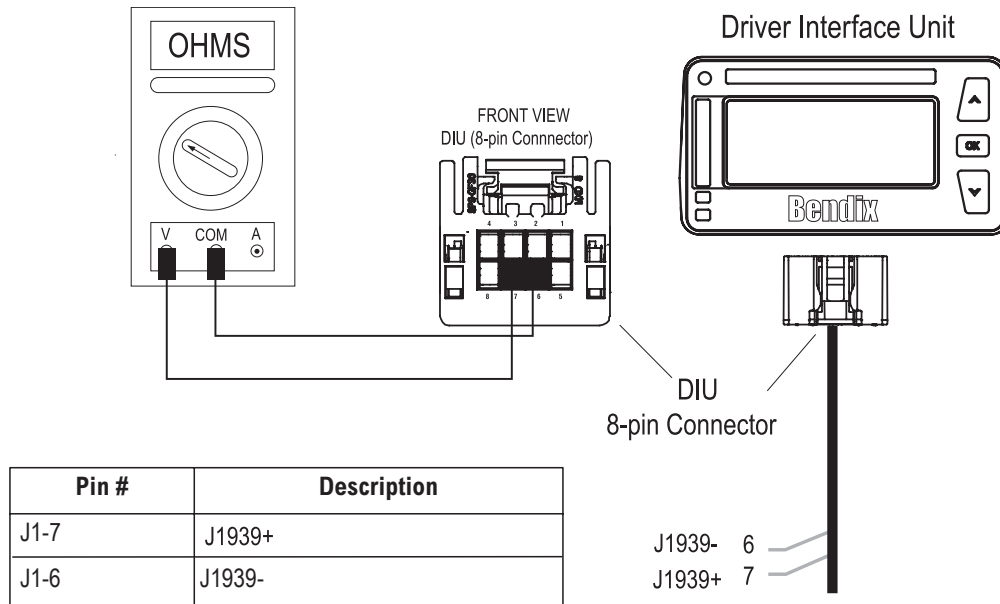
Step	Procedure
F	<ol style="list-style-type: none"> 1. Vehicle Ignition: Key-OFF. 2. Measure for J1939 data link resistance across pins 7 and 6 of the DIU harness connector. (J1939 High to J1939 Low) <ol style="list-style-type: none"> a. If the resistance is between 57 and 63 ohms. <ol style="list-style-type: none"> i. Proceed to Step G. b. If the resistance is greater than 63 ohms or open (Infinite Resistance.) <ol style="list-style-type: none"> i. Test Failed. Check for missing J1939 data link terminating resistor(s) or open/loose connections in the vehicle's J1939 data link harness. (See Note) c. If the resistance is less than 57 ohms or near zero. <ol style="list-style-type: none"> i. Test Failed. Check for shorted connections in the vehicle's J1939 data link harness. Unplug all J1939 data link components from the data link to isolate a potential defective component. (See Note) <p>Note: Refer to vehicle OEM repair manual or contact the OEM for more information on the J1939 data link harness.</p>

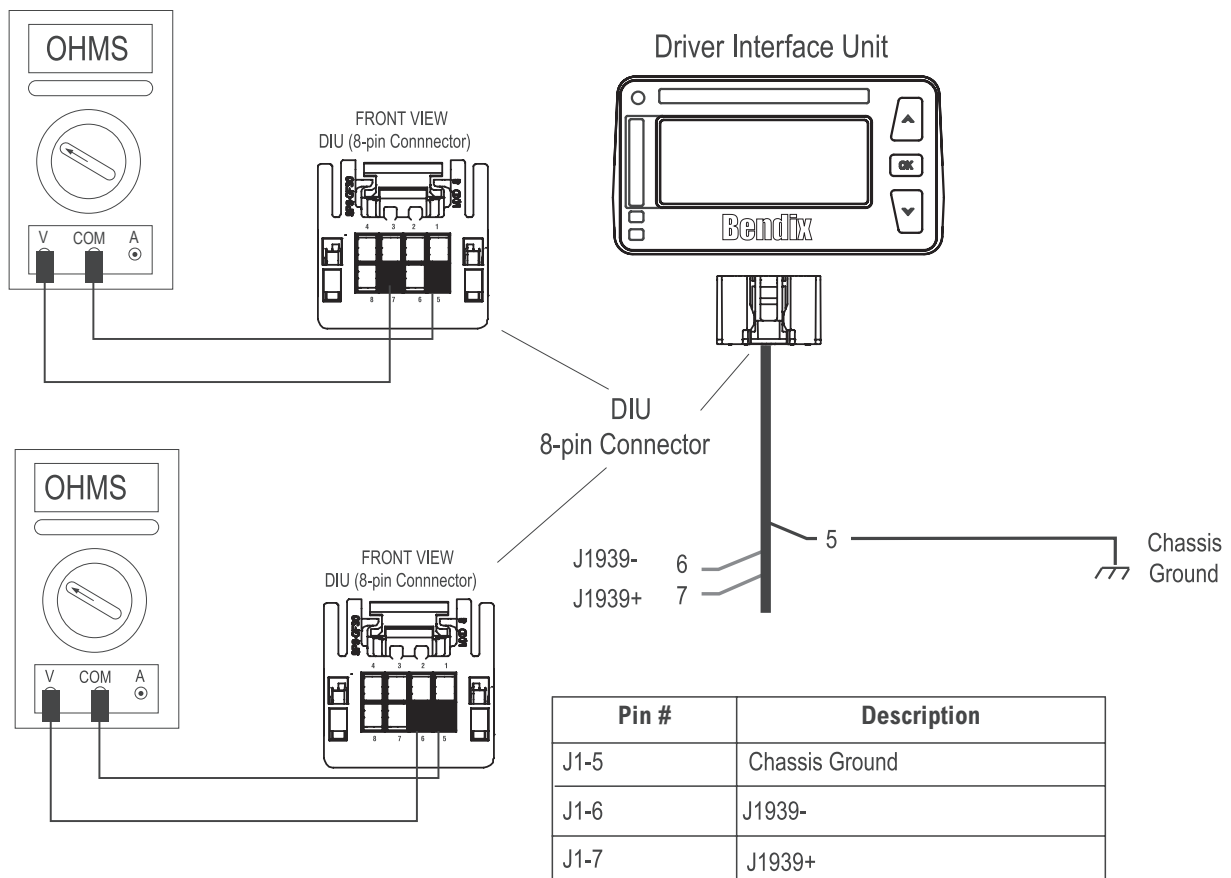
Step	Procedure
G	<ol style="list-style-type: none"> 1. Vehicle Ignition: Key-OFF. 2. Measure the resistance across pins 7 and 5 (J1939 High to Ground.) 3. Measure the resistance across pins 6 and 5 (J1939 Low to Ground.) <ol style="list-style-type: none"> a. If both resistances are greater than 100K ohms or open (Infinite Resistance). <ol style="list-style-type: none"> i. Proceed to Step H. b. If either resistance is between 0 to 100K ohms. <ol style="list-style-type: none"> i. Test Failed. Check for shorted connections in the vehicle's J1939 data link harness. Unplug all J1939 data link components from the data link to isolate a potential defective component. (See Note) <p>Note: Refer to vehicle OEM repair manual or contact the OEM for more information on the J1939 data link harness.</p>

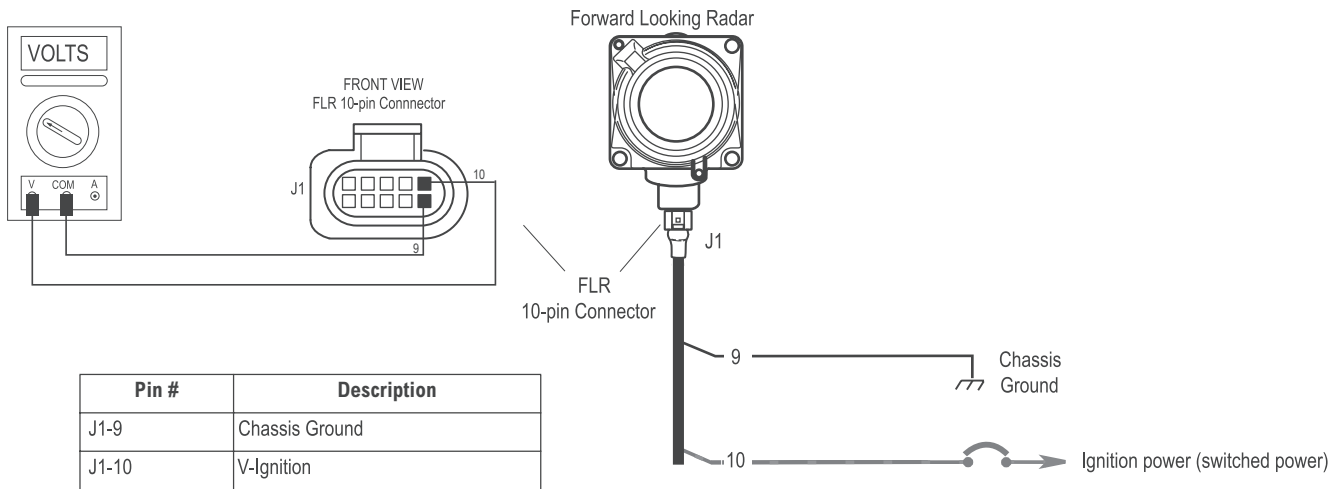
Step	Procedure
H	<ol style="list-style-type: none"> 1. Vehicle Ignition: Key-OFF, Engine-OFF. 2. Disconnect the 10-way connector from the VS-400 Forward Looking Radar (FLR). 3. Measure for zero voltage on pins 10 and 9 on the harness connector. <ol style="list-style-type: none"> a. If the voltage is 0.5 volts or less. <ol style="list-style-type: none"> i. Proceed to Step I. b. If the voltage is greater than 0.5 volts, but less than battery voltage. <ol style="list-style-type: none"> i. Test Failed. Check FLR power supply wiring for sources of stray voltage or shorts to voltage. c. If the voltage is within 0.6 volts of the vehicle battery voltage measured in Step A: <ol style="list-style-type: none"> i. Test Failed. The FLR is improperly wired to battery power. Correct the wiring by connecting the FLR to ignition power and repeat Step.

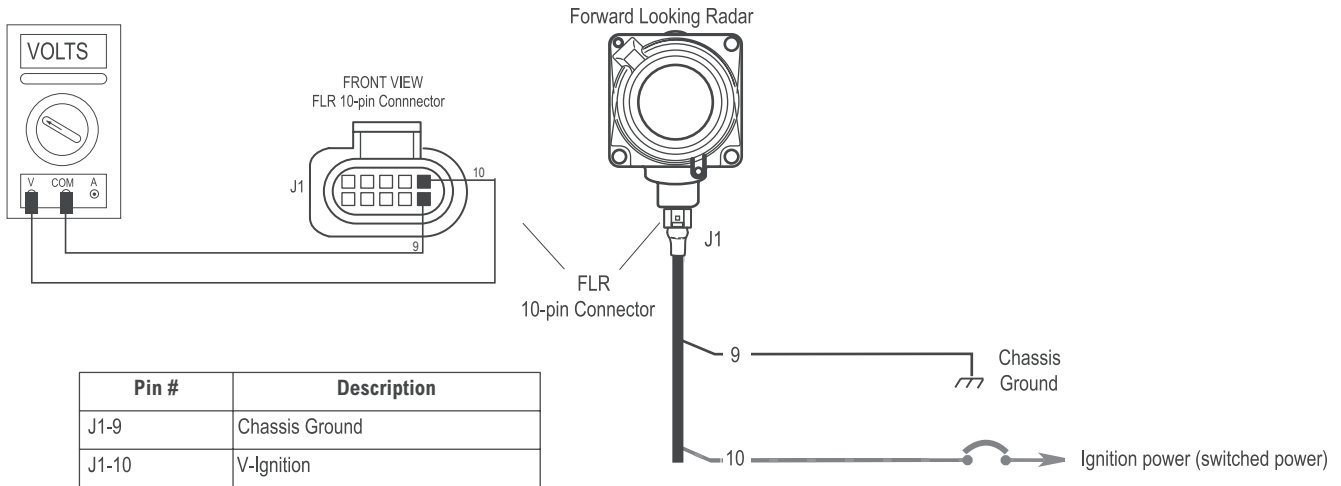
Step	Procedure
I	<ol style="list-style-type: none"> 1. Vehicle Ignition: Key-ON, Engine-OFF. 2. Measure for ignition voltage on pins 10 and 9 of the harness connector. <ol style="list-style-type: none"> a. If the voltage is within 0.6 volts of the battery voltage measured in Step A. <ol style="list-style-type: none"> i. Proceed to Step J. b. If the voltage is less than 0.6 volts of the battery voltage measured in Step A or open. <ol style="list-style-type: none"> i. Test Failed. Check component fuse. Troubleshoot power supply to the FLR for open/corroded connections or shorts to ground and repeat Step.

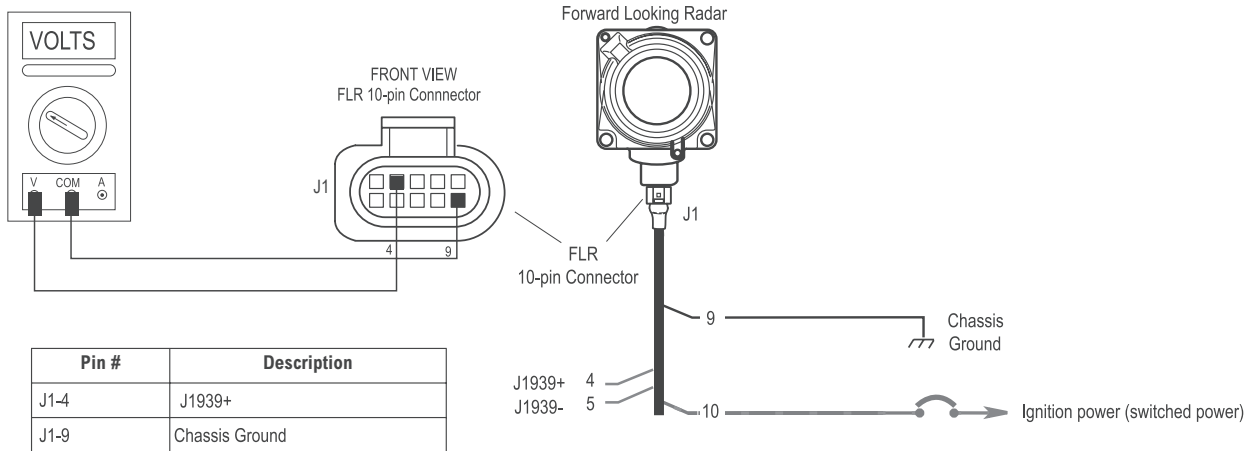
Step	Procedure
J	<ol style="list-style-type: none"> 1. Vehicle Ignition: Key-ON, Engine-OFF. 2. Measure for J1939 data voltage on pins 4 and 9 of the FLR harness connector. (J1939 High to Ground) <ol style="list-style-type: none"> a. If the voltage is fluctuating between 2 to 5 volts. <ol style="list-style-type: none"> i. Proceed to Step K. b. If the voltage is a constant 0 volts. <ol style="list-style-type: none"> i. Test Failed. Check for open / loose connections in the vehicle's J1939 data link harness. (See Note) <p>Note: Refer to vehicle OEM repair manual or contact the OEM for more information on the J1939 data link harness.</p>

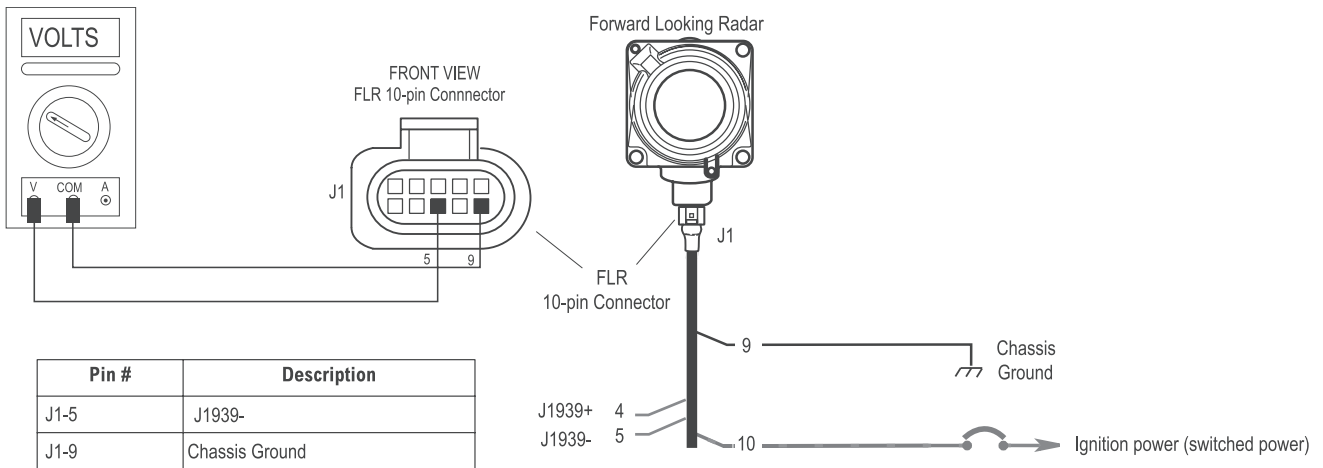
Step	Procedure
K	<ol style="list-style-type: none"> 1. Vehicle Ignition: Key-ON, Engine-OFF. 2. Measure for J1939 data voltage on pins 5 and 9 of the FLR harness connector. (J1939 Low to Ground) <ol style="list-style-type: none"> a. If the voltage is fluctuating between 0 to 3 volts. <ol style="list-style-type: none"> i. Proceed to Step L. b. If the voltage is a constant 0 volts. <ol style="list-style-type: none"> i. Test Failed. Check for open / loose connections in the vehicle's J1939 data link harness. (See Note) <p>Note: Refer to vehicle OEM repair manual or contact the OEM for more information on the J1939 data link harness.</p>

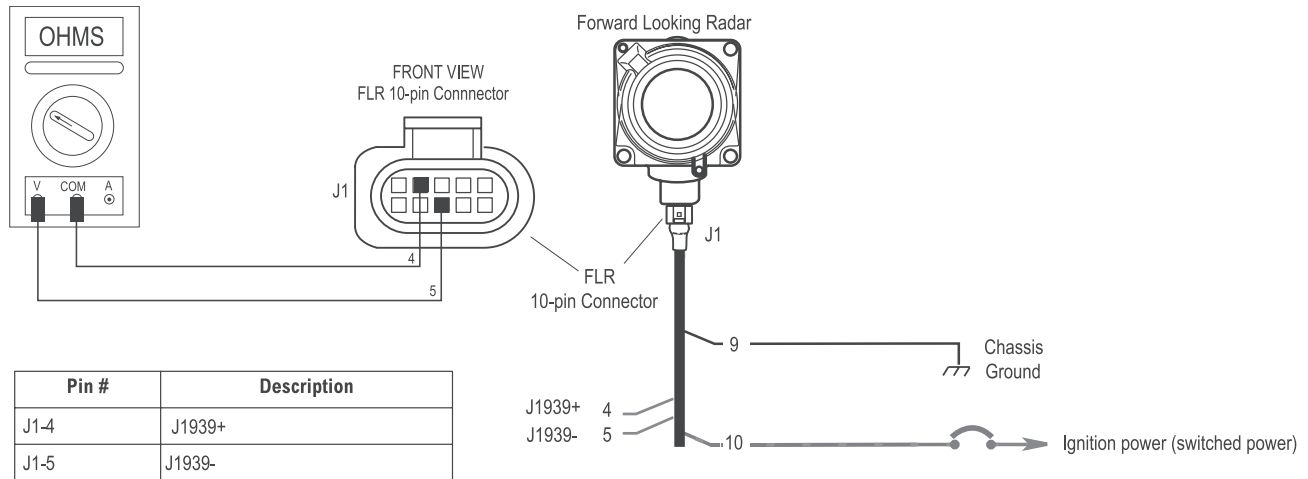
Step	Procedure
L	<ol style="list-style-type: none"> 1. Vehicle Ignition: Key-OFF. 2. Measure the J1939 data link resistance across pins 4 and 5 of the FLR harness connector. (J1939 High to J1939 Low) <ol style="list-style-type: none"> a. If the resistance is between 57 and 63 ohms. <ol style="list-style-type: none"> i. Proceed to Step M. b. If the resistance is greater than 63 ohms or open (Infinite Resistance.) <ol style="list-style-type: none"> i. Test Failed. Check for missing J1939 data link terminating resistor(s) or open / loose connections in the vehicle's J1939 data link harness. (See Note) c. If the resistance is less than 57 ohms or near zero. <ol style="list-style-type: none"> i. Test Failed. Check for shorted connections in the vehicle's J1939 data link harness. Unplug all J1939 data link components from the data link to isolate a potential defective component. (See Note) <p>Note: Refer to vehicle OEM repair manual or contact the OEM for more information on the J1939 data link harness.</p>

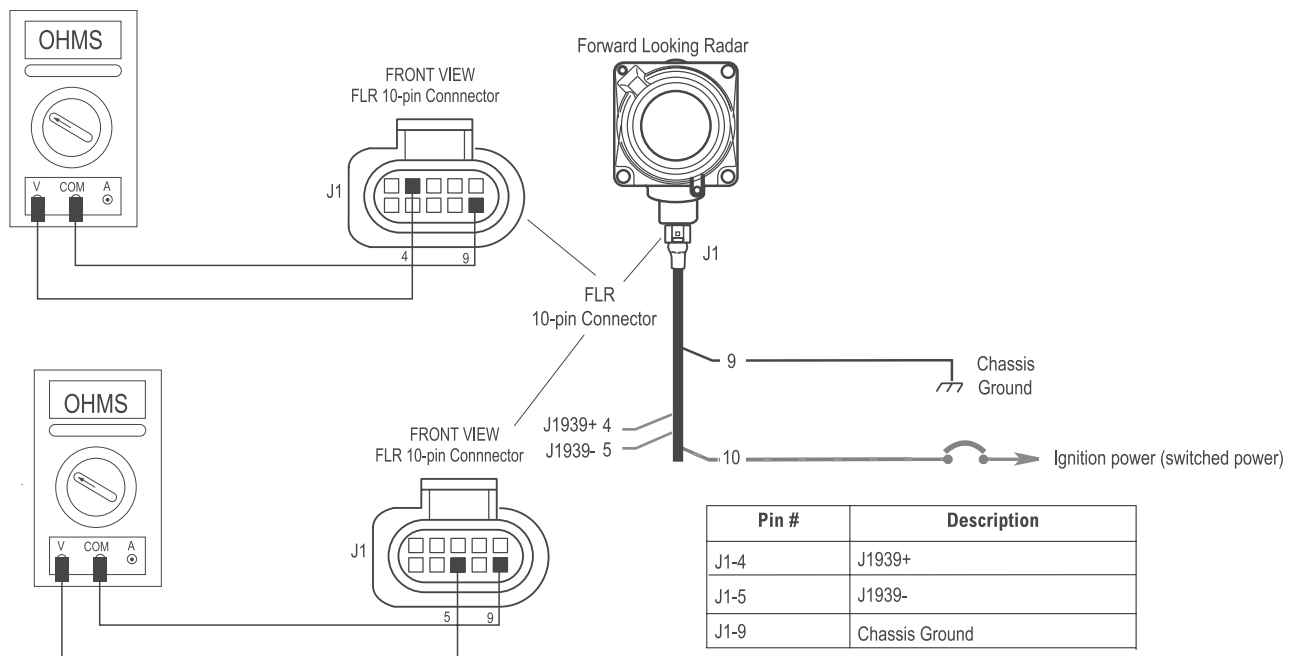
Step	Procedure
M	<ol style="list-style-type: none"> 1. Vehicle Ignition: Key-OFF. 2. Measure the resistance across pins 4 and 9 (J1939 High to Ground). 3. Measure the resistance across pins 5 and 9 (J1939 Low to Ground). <ol style="list-style-type: none"> a. If the resistance is greater than 100K ohms or open (Infinite Resistance). <ol style="list-style-type: none"> i. Test Complete. b. If the resistance is between 0 to 100K ohms. <ol style="list-style-type: none"> i. Test Failed. Check for shorted connections in the vehicle's J1939 data link harness. Unplug all J1939 data link components from the data link to isolate a potential defective component. (See Note) <p>Note: Refer to vehicle OEM repair manual or contact the OEM for more information on the J1939 data link harness.</p>

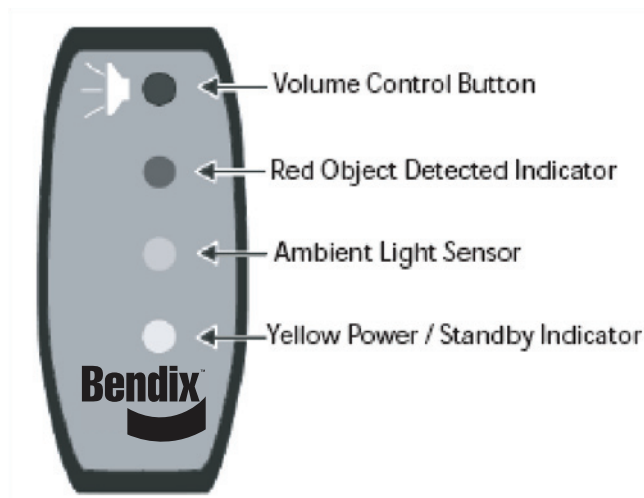
When the vehicle's ignition is turned to the ON position, the SOD display will power up by initially illuminating both the red and yellow lamps, indicating the system is performing its self test. Once the self test is complete and no objects are within a 15 foot radius of the sensor, the red lamp turns off while the yellow lamp remains illuminated, indicating the system is operational.

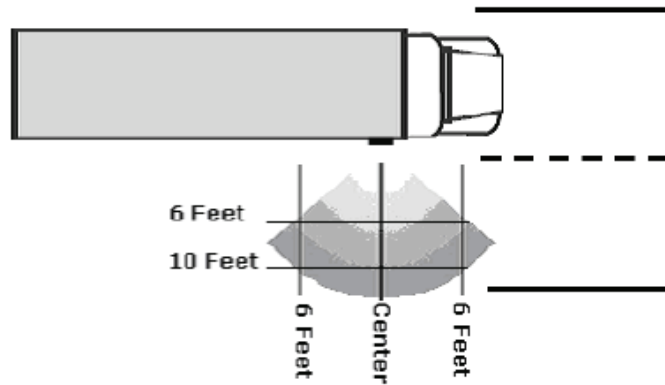
When an object is detected within the sensor's detection zone, the driver display illuminates the red detect lamp. During normal operation, the display will toggle between illuminating either the yellow or the red lamps, but never both at the same time (See SOD Failure Diagnostic Procedure).

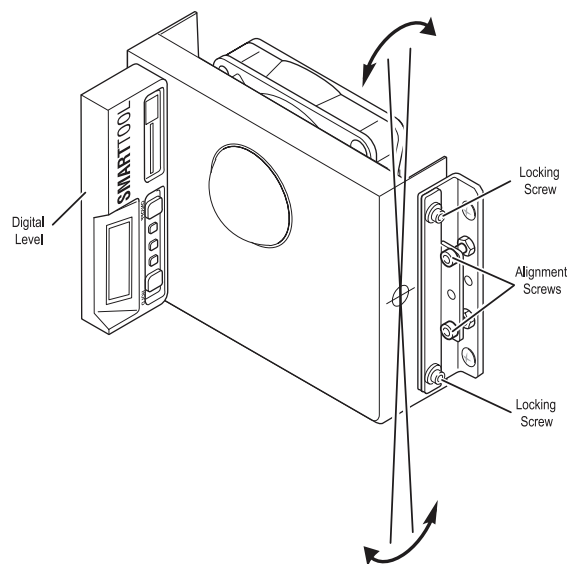
3. Adjust the alignment screws until the digital level reads down $0^\circ \pm .2^\circ$.
4. Once aligned, tighten the locking screws.

Note: The illustration below shows a typical mounting and mounting bracket. The design may vary.

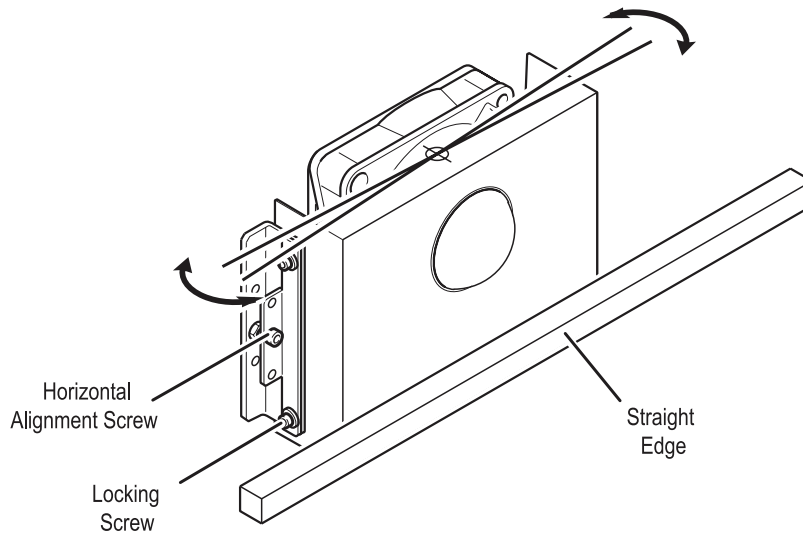
5. Adjust the alignment screw until the two measurement points are equal within +/- 0.1" (2.54mm).
6. Once the measurements are equal for both of the reference points, tighten the locking screws.
7. Check both the vertical and horizontal alignment:
 - a. Re-measure the reference points to ensure they are equal.
 - b. Use the digital level to verify the vertical alignment is still face down 0° from vertical \pm .2°.

Note: The illustration below shows a typical mounting and mounting bracket. The design may vary.

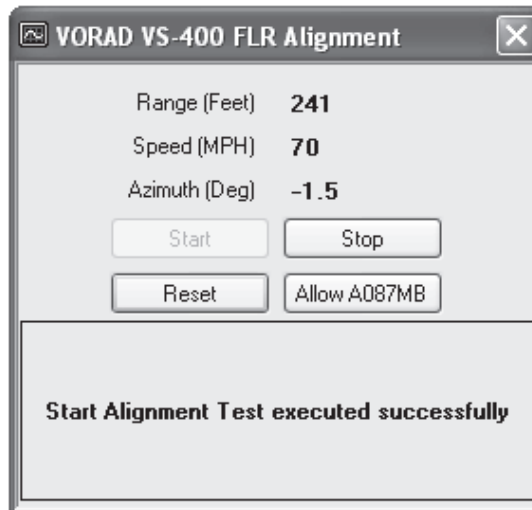
Continue to run the truck for a period of time (2-5 min), monitoring the azimuth value. As long as the vehicle the VORAD® system is tracking is in the same lane, the azimuth position should be 0°, but fluctuations in driving techniques may cause the vehicle to drift +/- 0.3°. If this value cannot be consistently kept, click the "Reset" button again and monitor the azimuth position. If the position is consistently more than 0.5° or less than -0.5°, the FLR horizontal alignment must be adjusted based on the average azimuth position.

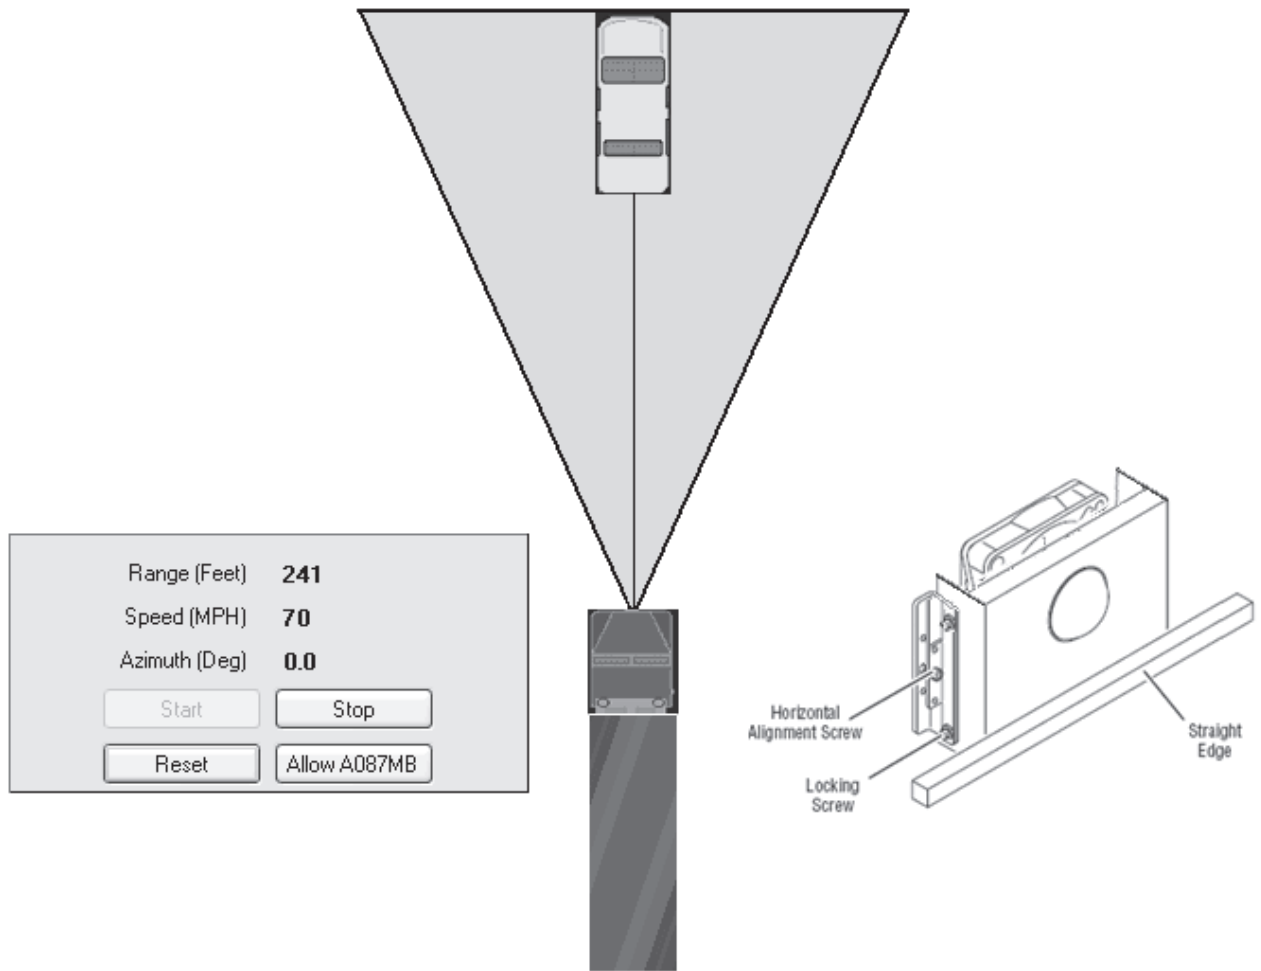
Center FLR Azimuth Position (FLR aligned correctly)

If the alignment function consistently shows an azimuth value of 0° +/- 0.5° when tracking a vehicle in the same lane, then the FLR is properly centered. In this case, the FLR does not need to be further aligned and the procedure is complete.

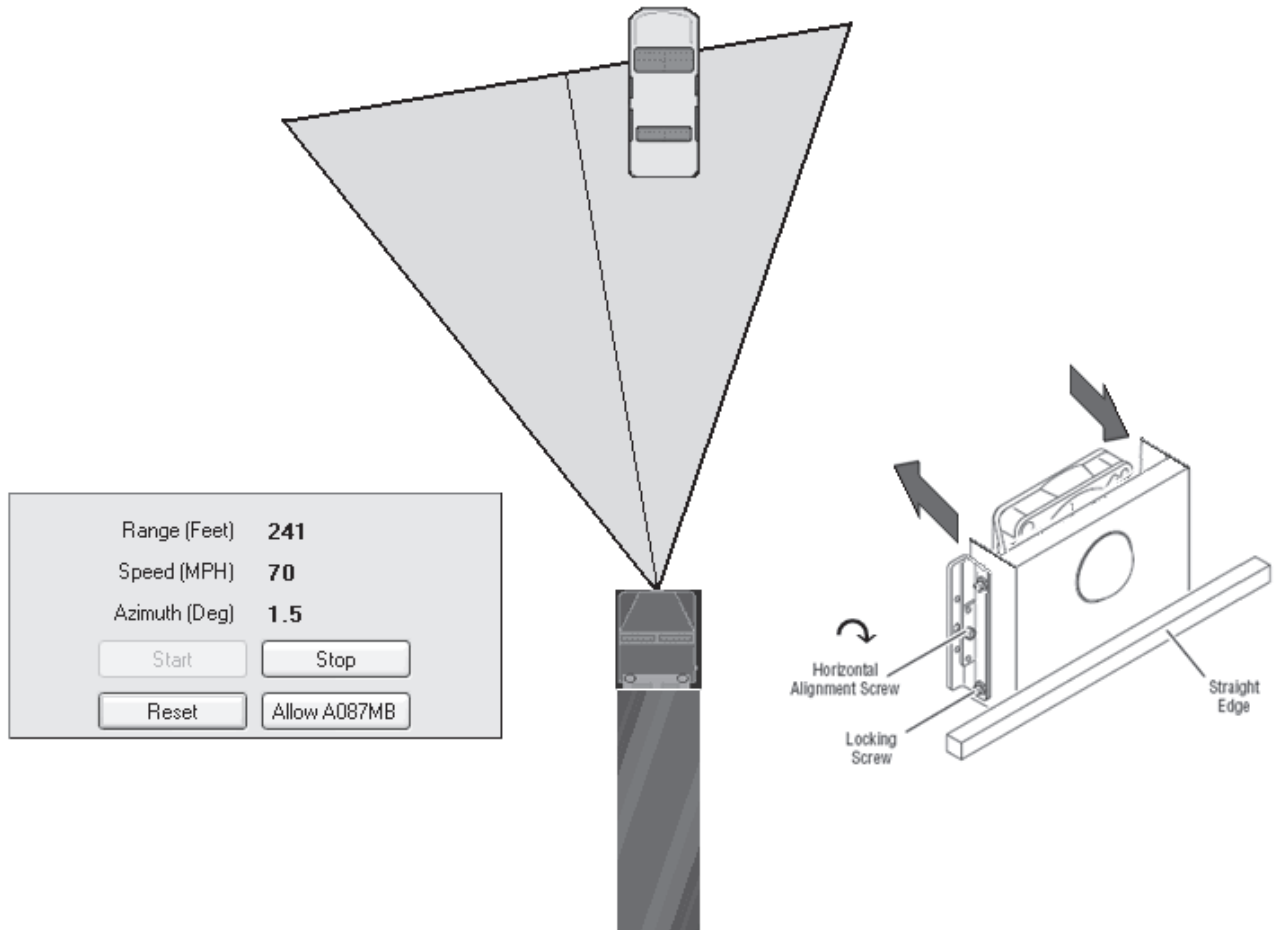
Negative Azimuth Adjustment (FLR too far to the left)

If the alignment function shows a positive value, then the FLR is adjusted too far to the left, when looked at from the driver's seat. The radar needs to be adjusted to the driver's right. To accommodate this, adjust the horizontal alignment screw by turning it in a clockwise direction, when viewed from the front of the vehicle. Each full rotation of the alignment screw adjusts for approximately 0.2° of azimuth position from the alignment function. For example, if the azimuth position was 0.5° , then the alignment screw should be adjusted $2\frac{1}{2}$ turns clockwise.

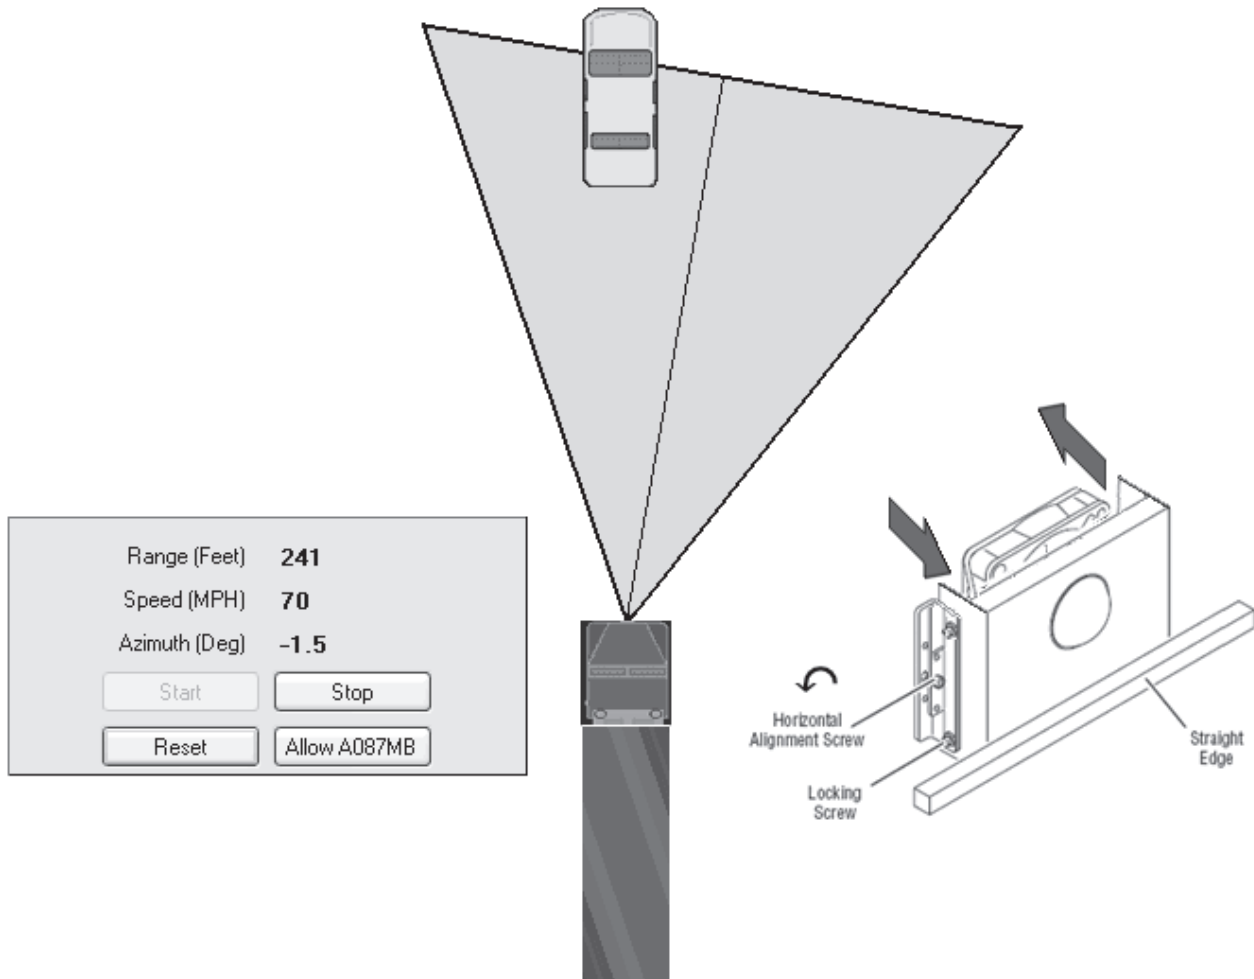
Positive Azimuth Adjustment (FLR too far to the Right)

If the alignment function shows a negative value, then the FLR is adjusted too far to the right, when looked at from the driver's seat. The radar needs to be adjusted to the driver's left. To accommodate this, adjust the horizontal alignment screw, by turning it in a counter-clockwise direction, when viewed from the front of the vehicle. Each full rotation of the alignment screw adjusts for approximately 0.2° of azimuth position from the alignment function. For example, if the azimuth position was -0.5° , then the alignment screw should be adjusted $2\frac{1}{2}$ turns counter-clockwise.

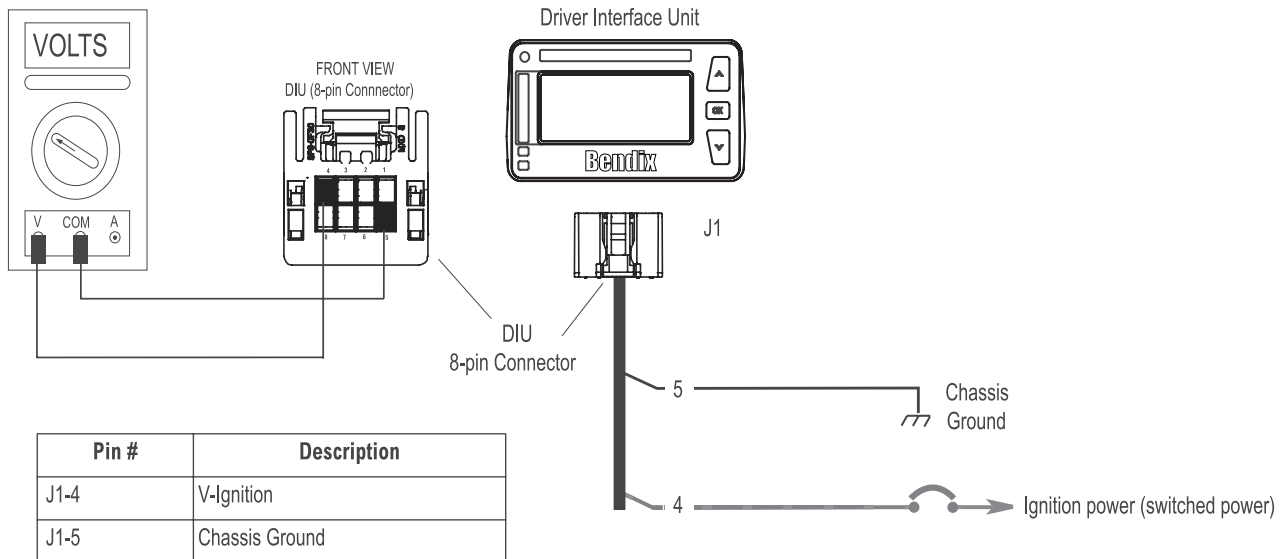
Step	Procedure
A	<ol style="list-style-type: none"> 1. Vehicle Ignition: Key-OFF, Engine-OFF. 2. Disconnect the 8-way connector from the back of the VS-400 Driver Interface Unit (DIU). 3. Measure for zero voltage on pins 4 and 5 on the harness connector. <ol style="list-style-type: none"> a. If the voltage is 0.5 volts or less. <ol style="list-style-type: none"> i. Proceed to Step B. b. If voltage is greater than 0.5 volts but less than battery voltage. <ol style="list-style-type: none"> i. Test Failed. Check DIU power supply wiring for sources of stray voltage or shorts to voltage. c. If the voltage is within 0.6 volts of the battery voltage measured in Step A. <ol style="list-style-type: none"> i. Test Failed. The DIU is improperly wired or shorted to a battery power source. Correct the wiring by connecting the DIU to the main ignition power supply bus and repeat Step.

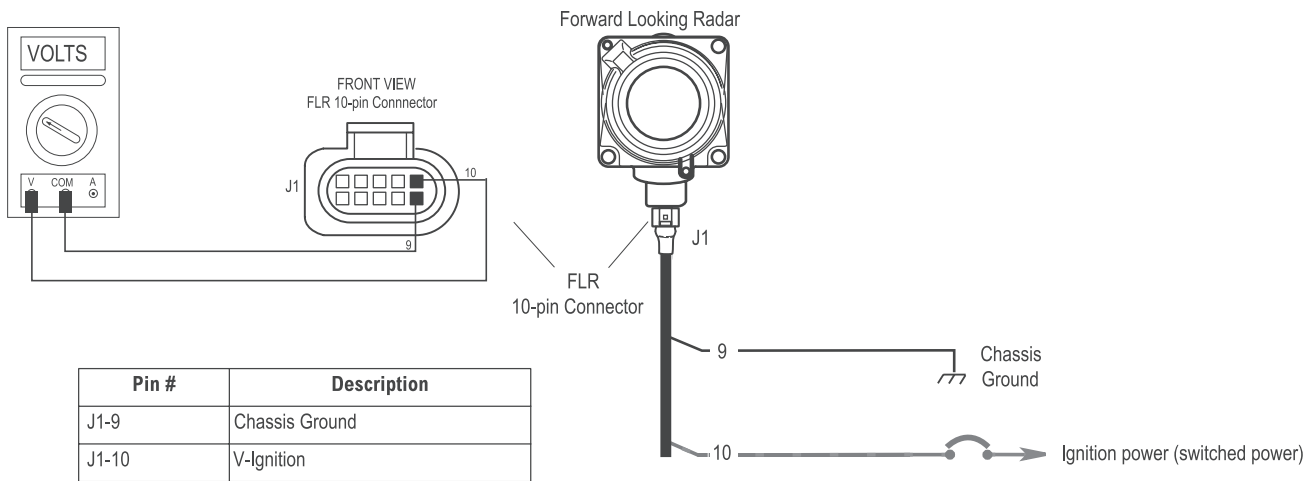
Step	Procedure
C	<ol style="list-style-type: none"> 1. Vehicle Ignition: Key-OFF, Engine-OFF. 2. Disconnect the 10-way connector from the VS-400 Forward Looking Radar (FLR). 3. Measure for zero voltage on pins 10 and 9 on the harness connector. <ol style="list-style-type: none"> a. If the voltage is 0.5 volts or less. <ol style="list-style-type: none"> i. Proceed to Step D. b. If voltage is greater than 0.5 volts but less than battery voltage. <ol style="list-style-type: none"> i. Test Failed. Check FLR power supply wiring for sources of stray voltage or shorts to voltage. c. If the voltage is within 0.6 volts of the battery voltage measured in Step A. <ol style="list-style-type: none"> i. Test Failed. The FLR is improperly wired or shorted to a battery power source. Correct the wiring by connecting the FLR to main ignition power supply bus and repeat Step.

Step	Procedure
D	<ol style="list-style-type: none"> 1. Vehicle Ignition: Key-ON, Engine-OFF. 2. Measure for ignition voltage on pins 10 and 9 on the harness connector. <ol style="list-style-type: none"> a. If the voltage is within 0.6 volts of the battery voltage measured in Step A. <ol style="list-style-type: none"> i. Proceed to Step E. b. If voltage is less than 0.6 volts of the battery voltage measured in Step A or open. <ol style="list-style-type: none"> i. Test Failed. Check component fuse. Troubleshoot power supply to the FLR for open / corroded connections or shorts to ground and repeat Step.

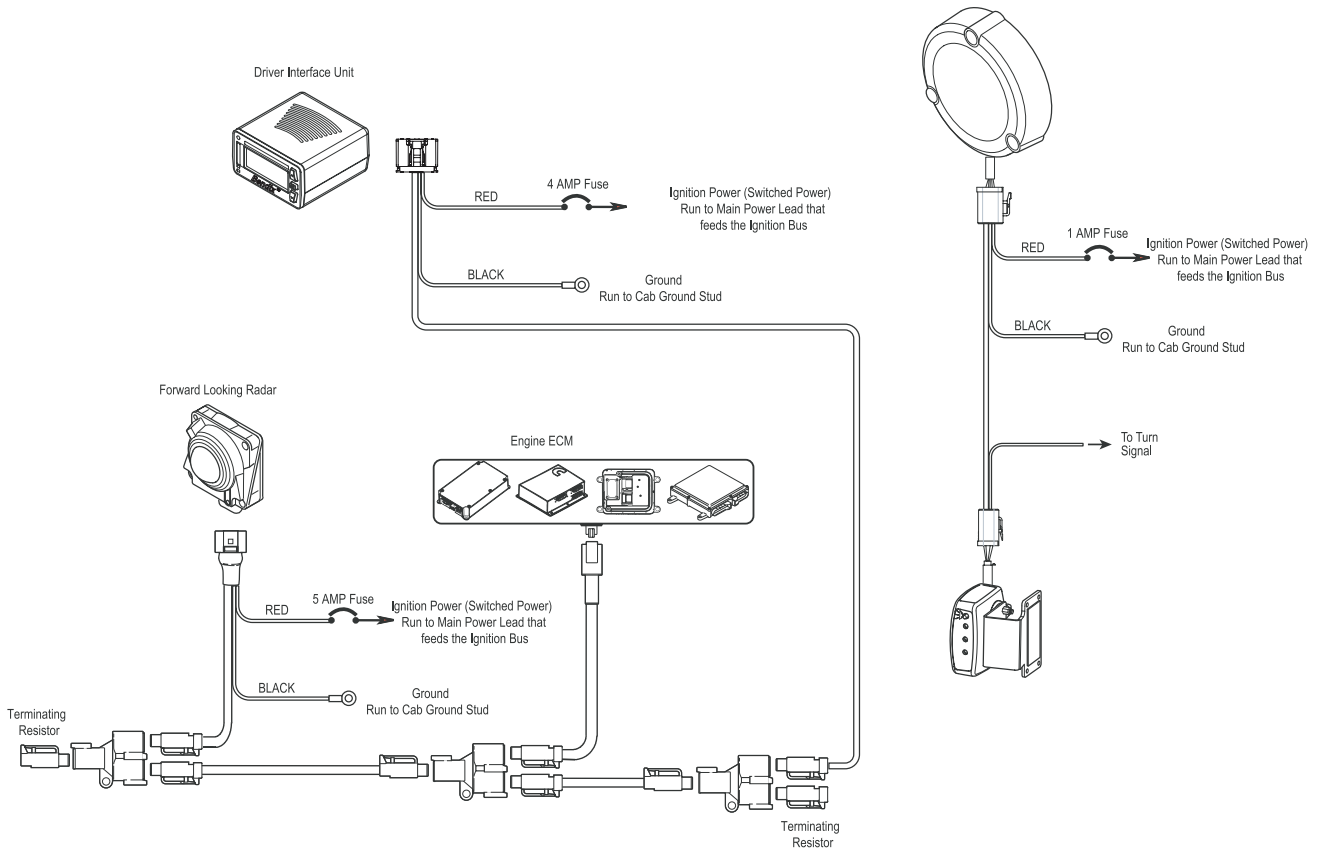
5. Wiring Diagrams

Collision Warning System with Side Object Detection

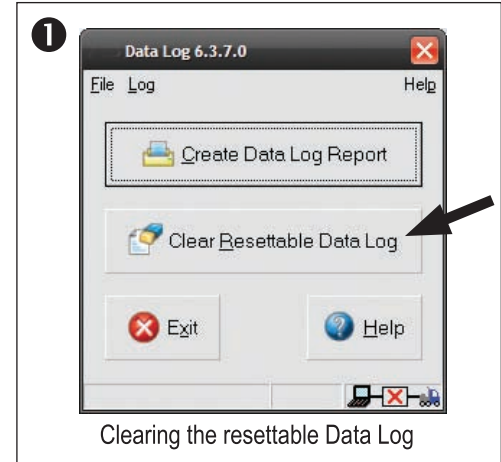
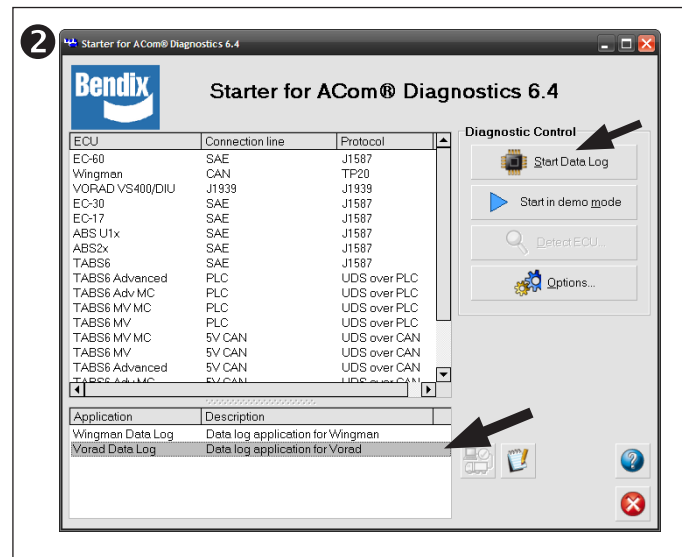
1. Bendix ACom Diagnostics 6.4 or higher is required for this procedure. The ACom Diagnostics software and its User Guide are available online at "Diagnostic Software" link under "Services and Support" on the Bendix website (www.bendix.com).
2. Obtain the Bendix VORAD "Data Extraction" license key from Bendix by calling the Tech Team at 1-800-AIR-BRAKE (1-800-247-2725).
3. After the diagnostics tool has been successfully connected to the vehicle, the service technician will be presented with the window shown to the right. See Diagram 2.
4. Select "VORAD Data Log", then select "Start Data Log".
5. Select "Clear Resettable Data Log".
6. Select "No" when asked if you want to save the Log.
7. Select "OK" to exit.

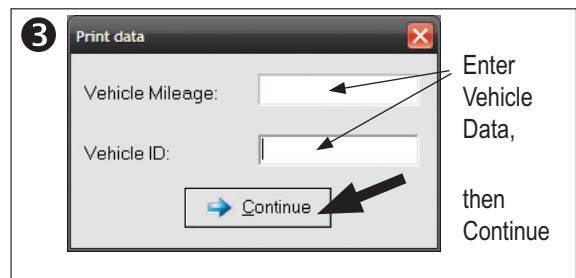
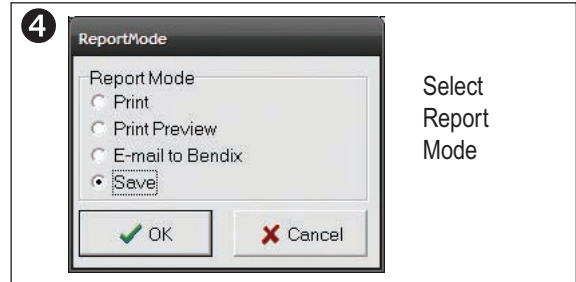
1. Bendix ACom Diagnostics 6.4 or higher is required for this procedure.
2. After the diagnostics tool has been successfully connected to the vehicle, the service technician will be presented with the window shown to the right. See Diagram 2.
3. Select "VORAD Data Log", then select "Start Data Log". See Diagram 2.
4. Select "Create Data Log Report". See diagram 1.
5. Enter the vehicle data (mileage, ID), select "Continue". See diagram 3.
6. Select the type of report you require ("Print", "Print Preview", "E-mail", or "Save"), then select "OK". See diagram 4.
7. After saving the report, if you wish to reset the log, select "yes".
